The PIDP was conducted in the central San Francisco Bay between October 23 and December 12, 2000 to evaluate engineering and environmental factors associated with installing large steel piles that would support a replacement structure or with installing piles as an element of retrofitting the existing bridge between Yerba Buena Island and the City of Oakland. The PIDP involved driving three steel pipe piles using two types of hydraulic hammers, one with a maximum energy rating of 500 kilojoules (kJ) (referred to as the small hammer) and one with a maximum rating of 1700 kJ (referred to as the large hammer). The PIDP also tested two different types of in-water sound attenuating equipment, an air bubble curtain and a proprietary fabric barrier system with an aerating mechanism, in addition to driving one pile without sound attenuating devices. As such, the PIDP was a demonstration project to investigate construction requirements, identify potential problems, make modifications to equipment, and examine effectiveness of sound attenuation devices for the East Span Project. Overall, the PIDP included a total of 12 hours and 51 minutes of pile driving for all segments.

CT SFOBB
EAST SPA

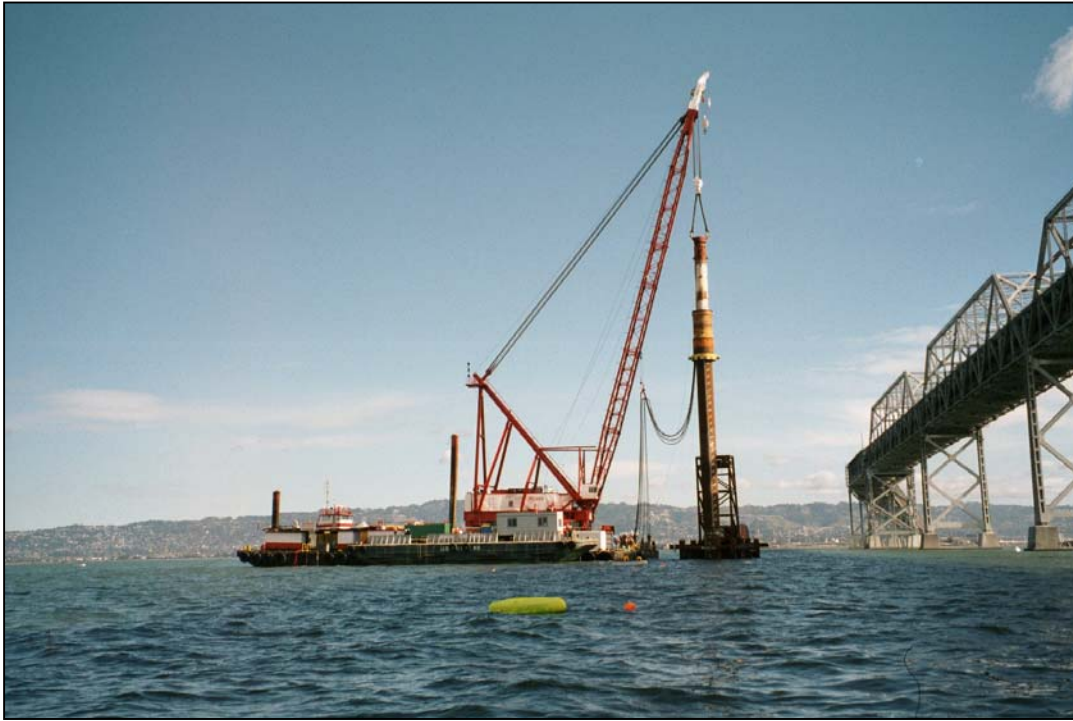
Figure 1-5. PIDP Barge and Large Hammer. (Note: Buoy in the foreground was used to support underwater sound monitoring instruments.)

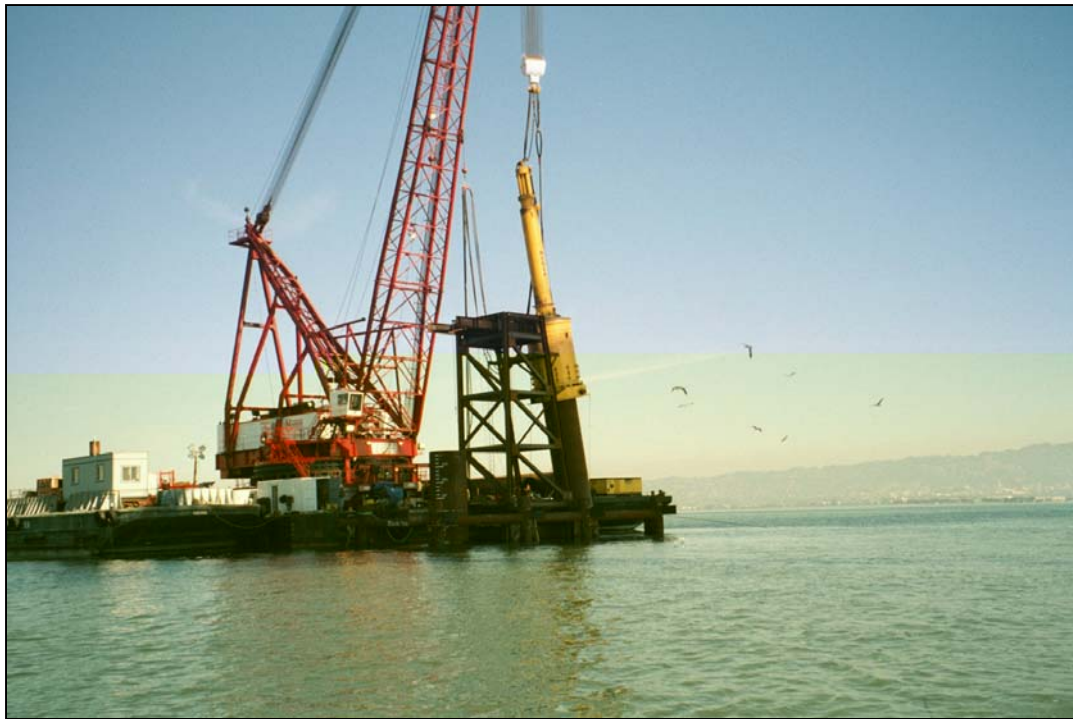
Figure 1-6. PIDP Barge and Small Hammer. (Note: Birds circling the area.)

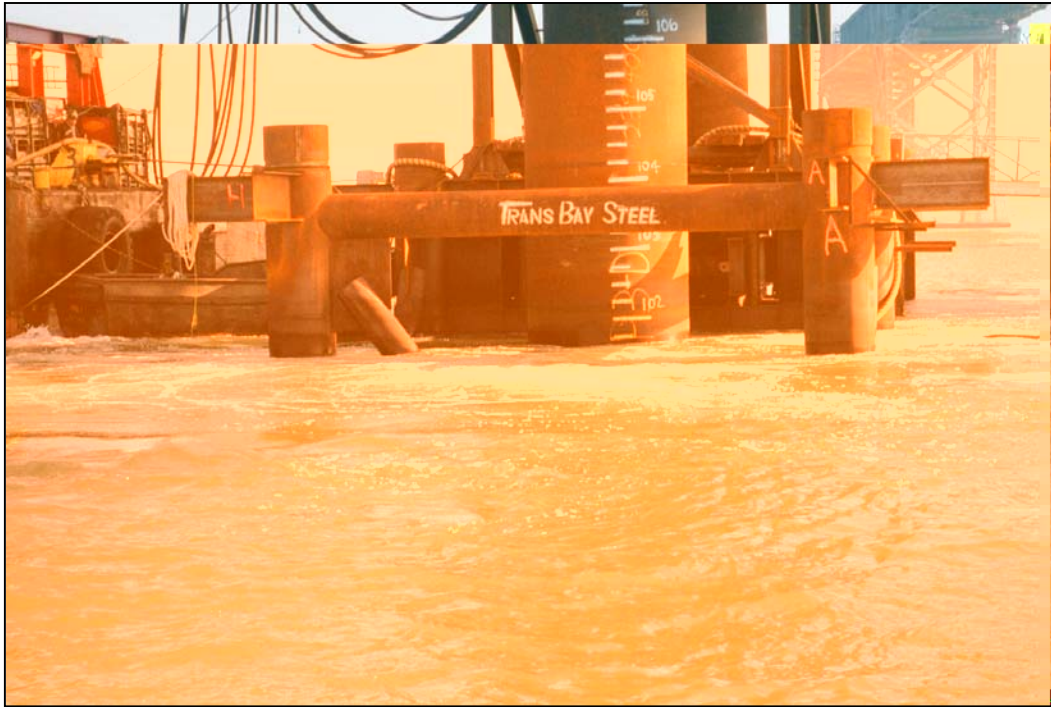
Figure 1-7. Air Bubble Curtain in Operation.

Pile 2 was a battered pile angled 1h:6v to the east and used an air bubble curtain. The air bubble curtain provides a curtain of air around the pile to attenuate noise from driving activities. Bubbles emerged from a submerged piping system that surrounded the pile template (used to hold the hammer/pile in place). The piping system was comprised of three 10.2-centimeter (4-inch) diameter perforated polyvinyl chloride (PVC) pipes attached to a steel frame, forming a 30.5-meter (100-foot) diameter octagonal ring. Two rows of 0.1-centimeter (0.04-inch) diameter holes were drilled into the PVC pipes. The bubble curtain system was fabricated and assembled off-site, then transported to the pile-driving site using a barge-mounted crane. The piping system ring was then submerged to the bay floor to encircle the pile template. Air was supplied from a 1600 cubic feet-per-minute (cfm) compressor located on the PIDP barge. Though Pile 2 was driven at an angle, the bubbles streamed straight up to the water surface, potentially providing less attenuation near the surface than at greater depths. A similar system was used by Würsig et al. (2000) for attenuating noise received by dolphins during pile driving activities for an airport expansion.

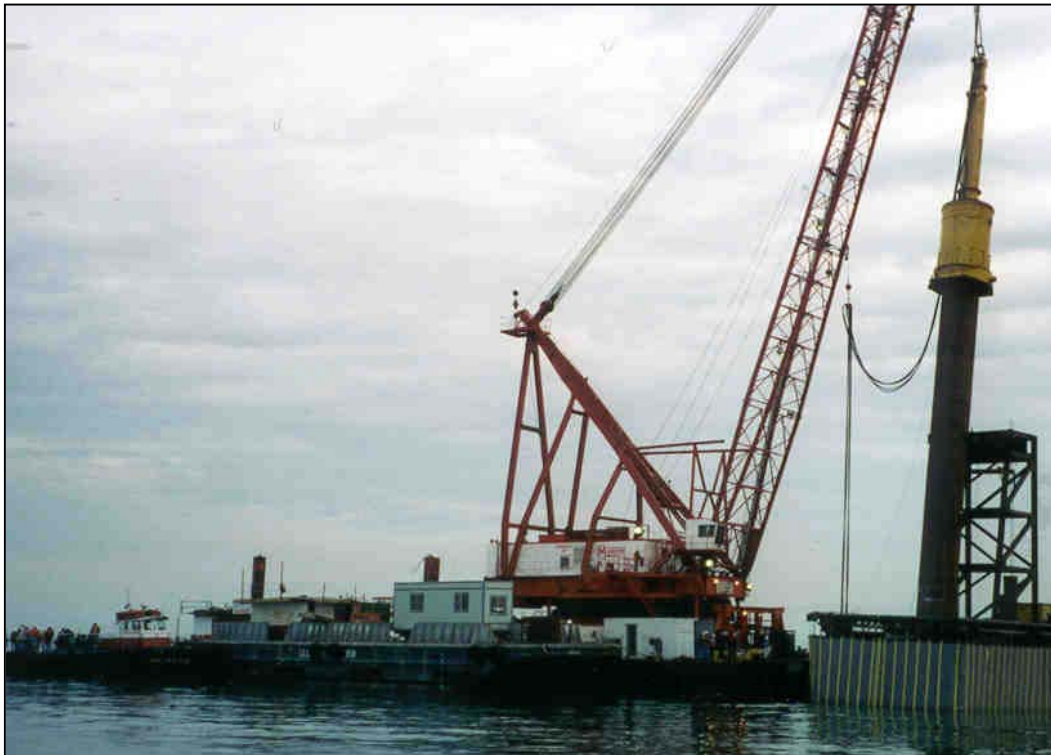
Figure 1-8. Fabric Barrier System with Aerating Mechanism (lower right corner of figure).

The fabric barrier system with aerating mechanism had a 10.7-meter by 22.9-meter (35-foot by 75-foot) rectangular footprint. This proprietary fabric barrier system with aerating mechanism was assembled and attached to the template off-site. The template/air bubble and fabric barrier was transported by barge to the Pile 3 location. Air was supplied from the same 1600 cfm compressor that was used on Pile 2; however, air was supplied to four pipes which were arranged in a smaller footprint than for the air bubble curtain, thereby providing a higher density of air bubbles around the pile.

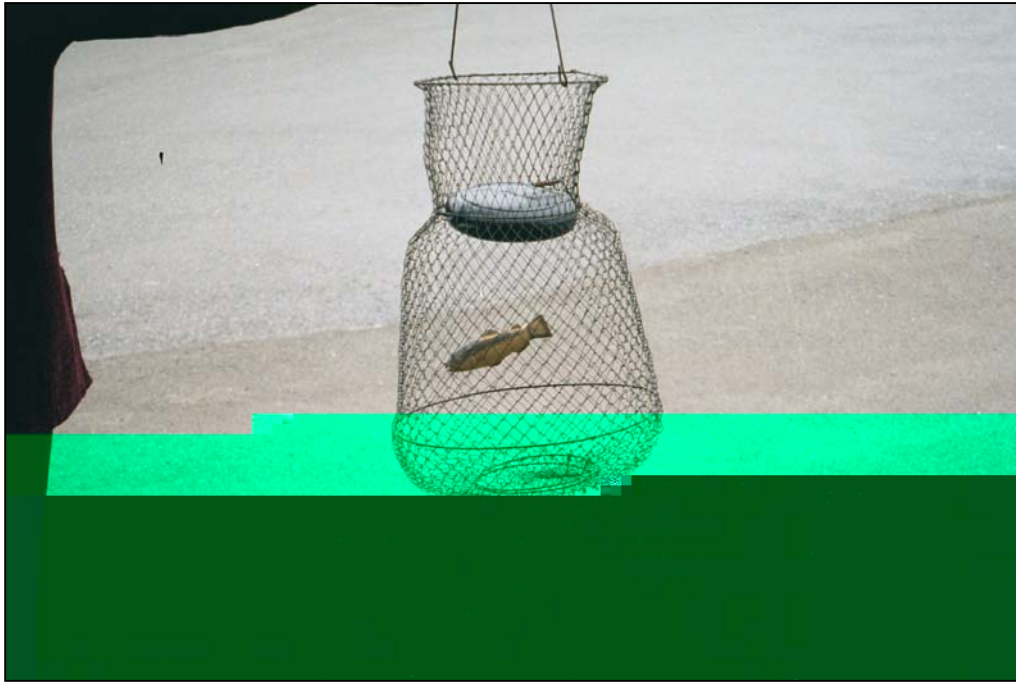
Figure 2-1. Experimental Fish Cage With Model Fish to Illustrate the Relative Size of the Fish and Cage.

Each cage was weighted by two spherical 900-gram (2-pound) weights attached to the bottom of the cage to help hold the cage approximately vertical in the water column in the strong tidal currents. A 1-centimeter (0.4-inch) diameter nylon rope tied to the top of the cage was used to suspend it from a floating buoy or cleat on the PIDP barge.

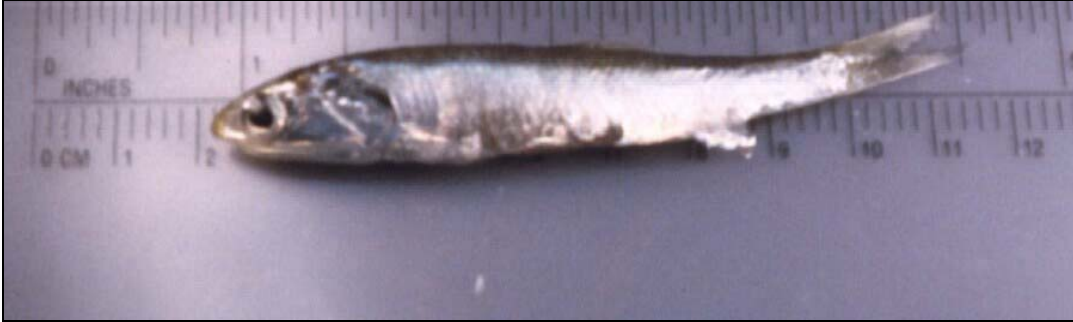
Figure 4-2. Anchovy Collected November 19, 2000 Showing Ruptures Behind the Gill Plate and at the Vent.

A number of fish were photographed to illustrate the varying degrees of damage observed. See Figures 4-2 through 4-7.

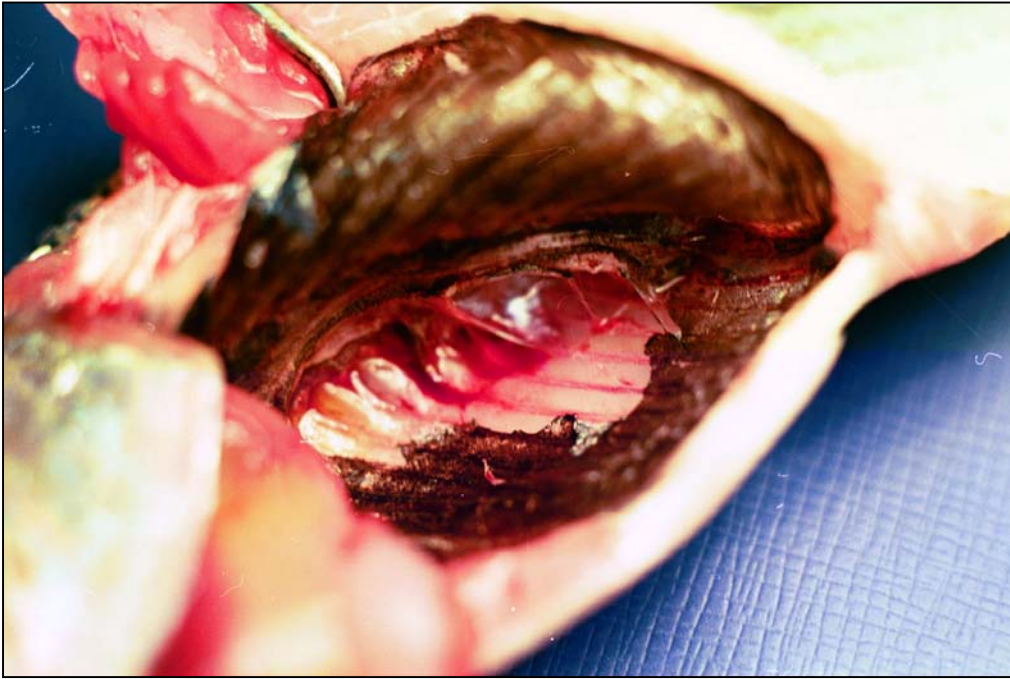
Figure 4-6. Ruptured Swim Bladder of a Pile Surfperch.
